## Aquatic Plant Community of Rice Lake: 2012

*Hennepin County, MN (DOW# 27-0116)*

James A. Johnson – *Aquatic Ecologist, Freshwater Scientific Services, LLC (Maple Grove, MN)*

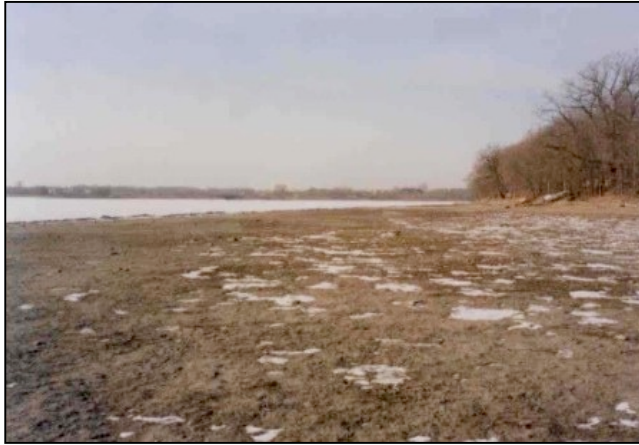
**Figure 4.** Exposed sediment during the Rice Lake drawdown conducted over the fall and winter of 2002-2003.

Rice Lake was drawn down (partially drained) in the fall and winter of 1996-1997, 1997-1998, 2002-2003 (Fig. 4), and 2004-2005 to control curlyleaf pondweed and Eurasian watermilfoil. These winter drawdowns were conducted to expose sediment in near-shore areas to allow for desiccation and freezing over the winter months. Past studies have suggested that such desiccation and freezing can kill buried curlyleaf turions and milfoil root-balls, leading to reduced levels of infestation in the years immediately following drawdowns.

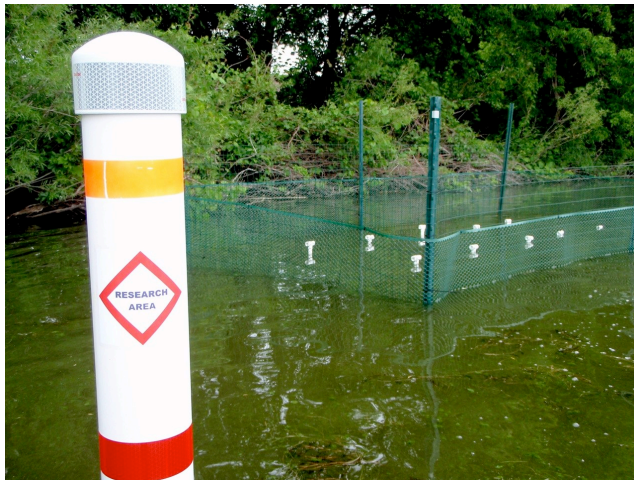
**Figure 5.** Carp enclosure study plot with plant markers and safety buoys (2011, Freshwater Scientific Services, LLC).

In 2011, Freshwater Scientific Services, LLC conducted a carp enclosure study in Rice Lake (Fig. 5) to determine whether carp activity was limiting plant growth in shallow near-shore areas of the lake (Johnson 2011). Results from this study indicated that carp were having a major impact on the survival and growth of aquatic plants in the lake. In addition, the study evaluated several species of plants to determine which native plants would most likely be able to reestablish in the lake if carp were controlled.

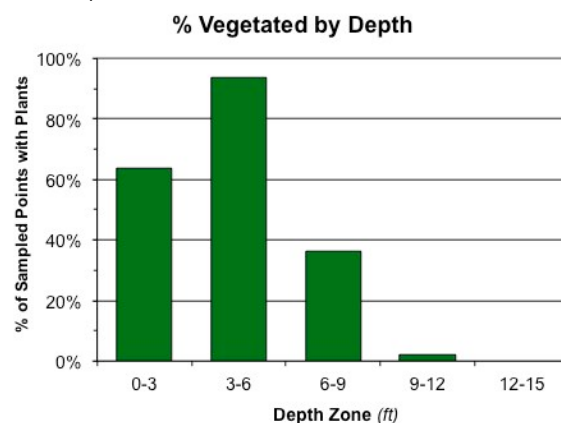
**Figure 8.** Percent of sampled points (by depth zone) where plants were found in June 2012

This aspect of the plant community is highly dependent upon water clarity. In Rice Lake, the maximum depth of growth in June 2012 was 10 ft (Table 4). However, most plant growth was found in areas shallower than 6 ft (Figs. 8 to 11).

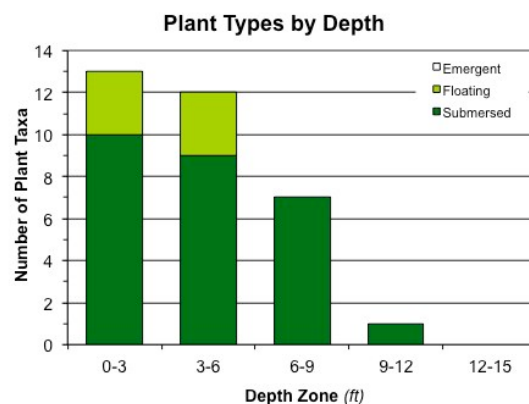
**Figure 9.** Number of plant species (grouped by type) found in each depth zone in June 2012

In June 2012, Rice Lake supported 13 different plant species (Table 3, Fig. 9). This is fairly typical of lakes with low water clarity and established infestations of curlyleaf pondweed and Eurasian watermilfoil.

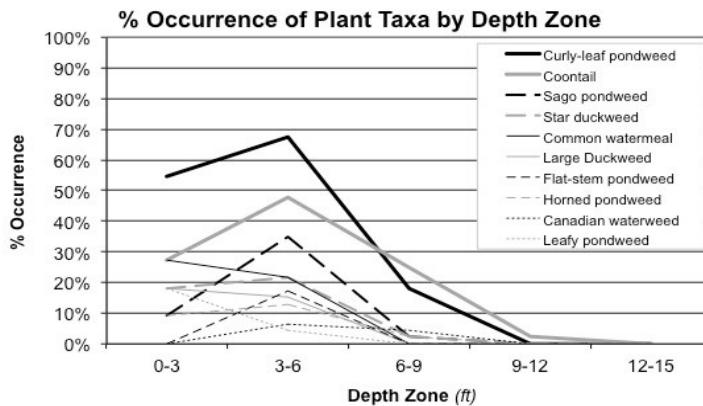
**Figure 10.** Frequency (% occurrence) of aquatic plant species by depth zone (June 2012)

We found 8 submersed native plant taxa in Rice Lake during the 2012 survey. However, coontail (*Ceratophyllum demersum*) was consistently the most frequently encountered and abundant native plant across all sampled depths (Figs. 10 and 11). All other plant taxa grew less densely (average littoral density rating  $\leq 1$ ) than coontail (Fig. 11).

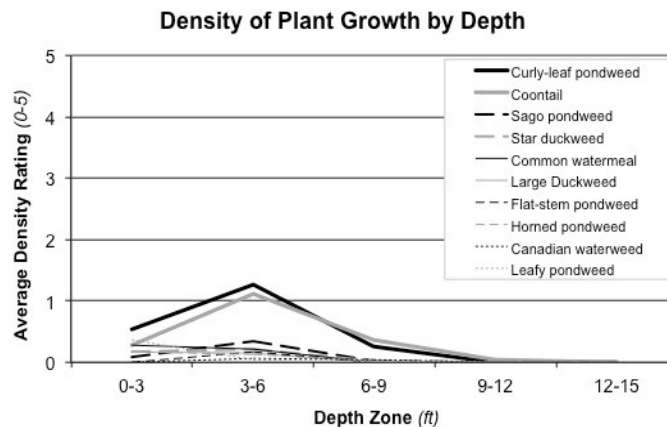
**Figure 11.** Plant density (0-5 rating; lake-wide average) of aquatic plant species by depth zone (June 2012)

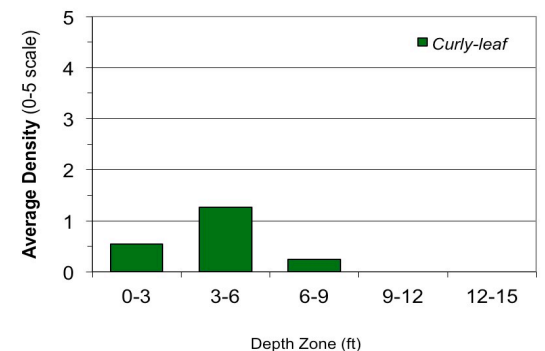
% Occurrence ( <i>littoral</i> )	22%
Max Depth of Growth (ft)	8.9
Average Density ( <i>littoral</i> )	0.4
Max Density	4.0

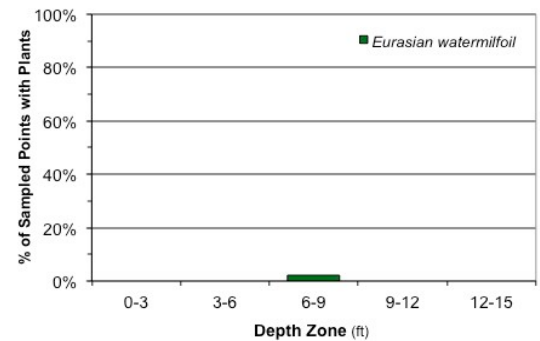
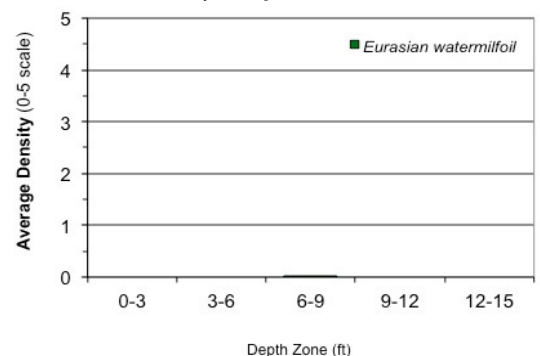
% Occurrence ( <i>littoral</i> )	<1%
Max Depth of Growth (ft)	6.2
Average Density ( <i>littoral</i> )	<0.1
Max Density	1.0

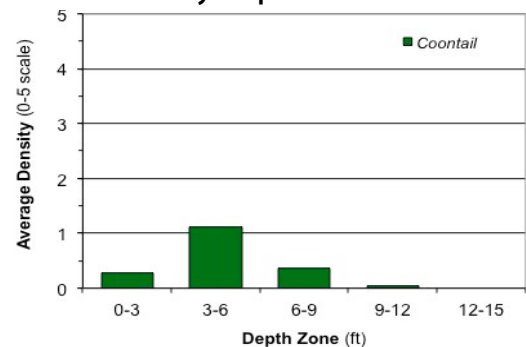
% Occurrence ( <i>littoral</i> )	19%
Max Depth of Growth ( <i>ft</i> )	10.2
Average Density ( <i>littoral</i> )	0.4
Max Density	4.0
